USAAEFA PROJECT NO. 77-05

ICING EVALUATION
U-21A AIRPLANE WITH
LOW REFLECTIVE PAINT

FINAL REPORT

MAY 1977

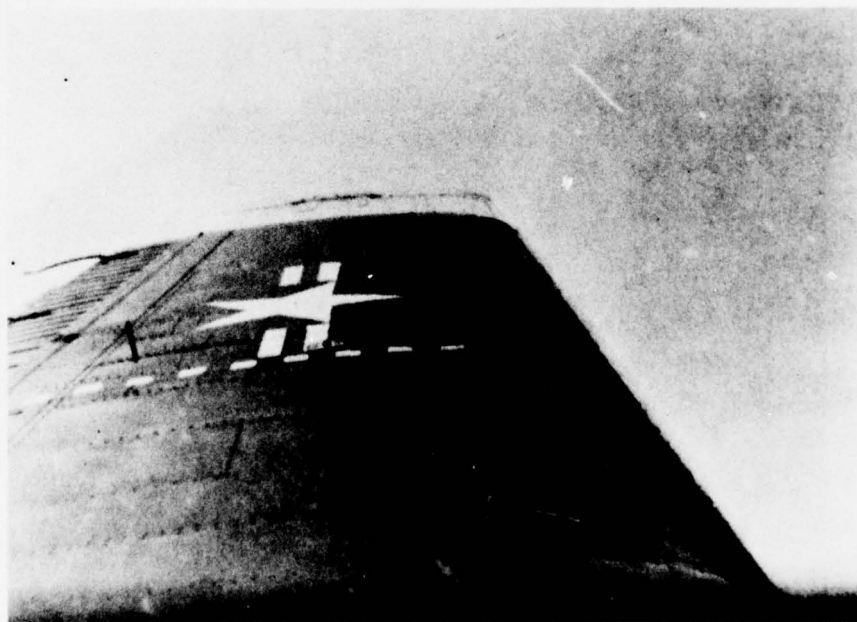
10. With constant power for 170 KCAS in level flight, an ice accumulation of 0.5 to 1 inch on the leading edges of the deicing boots resulted in a 20- to 30-knot loss in airspeed. At this same ice accumulation level, 170 KCAS could be maintained with full power applied to both engines. Photos 7 and 8, appendix B, show an ice accumulation of approximately 1 inch on the leading edges of the pneumatic deicing boots. After activation of the boots, the power required for level flight was reduced. The effectiveness of the deicing boots is further discussed in paragraph 13. To prevent unnecessary concern on the part of the flight crew the following NOTE should be incorporated in the operator's manual:

Photo 8. Approximately One Inch of Ice Accumulated on Leading Edge of Wing of Standard Aircraft.

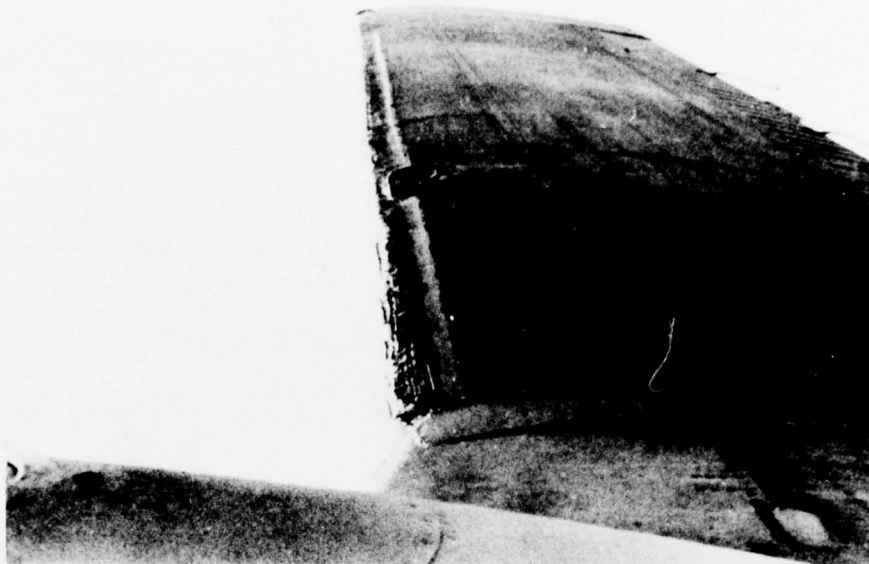
13. The effectiveness of the pneumatic boots differed with the type of ice that accumulated on the wing. With rime icing the boots did not adequately clear the ice. Photo 9, appendix B, depicts rime ice accumulation prior to activation of the boots. Photo 10 shows the wing after the boots were activated. Repeated use of the boots (six attempts) did not significantly clear more ice. With clear or mixed icing the boots were effective and ice was cleared by one application of the boots. The landing lights were used in one attempt (approximately 1 minute) to clear the large ice build-up on the wing tip. In the short period the landing light was used the ice did not shed from the wing tip. In any future U-21 icing tests, the possibility of anti-icing/deicing the wing area outboard of the boots by use of the landing lights should be investigated. The ineffectiveness of the deice boots with rime ice accumulation is a shortcoming.

**Photo 9. Approximately Two Inches of Rime Ice Accumulation
on Leading Edge of Test Aircraft.**

26. The shortcomings should be corrected.
27. Future U-21 icing tests should investigate the use of landing lights for anti-icing or deicing the wing area outboard of the pneumatic boots (para 8).
28. Conduct further testing to determine the effects of ice accumulation inside engine inlets and determine the effectiveness of the engine ice vanes in preventing foreign object damage (para 18).
29. Incorporate the following NOTE in the operator's manual (para 10):

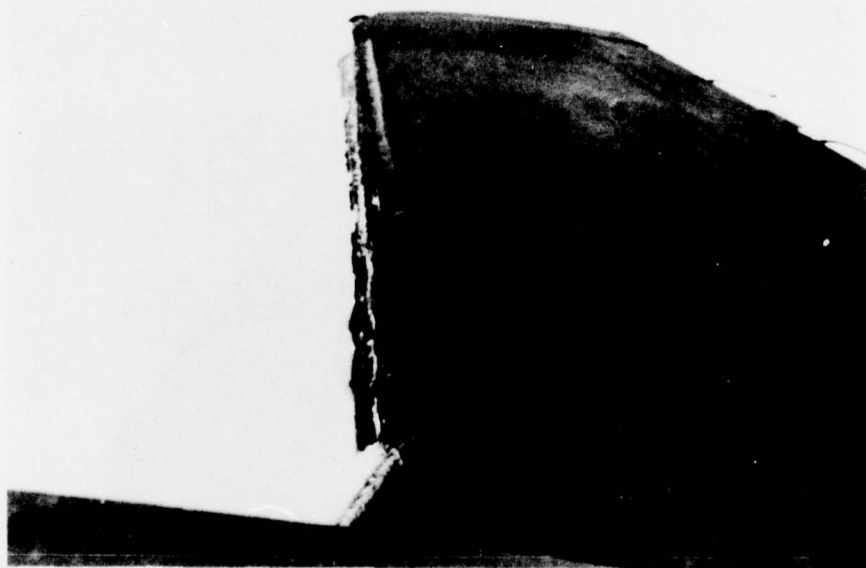
Photo 10. Rime Ice After Activation of Wing Deicer Boots.

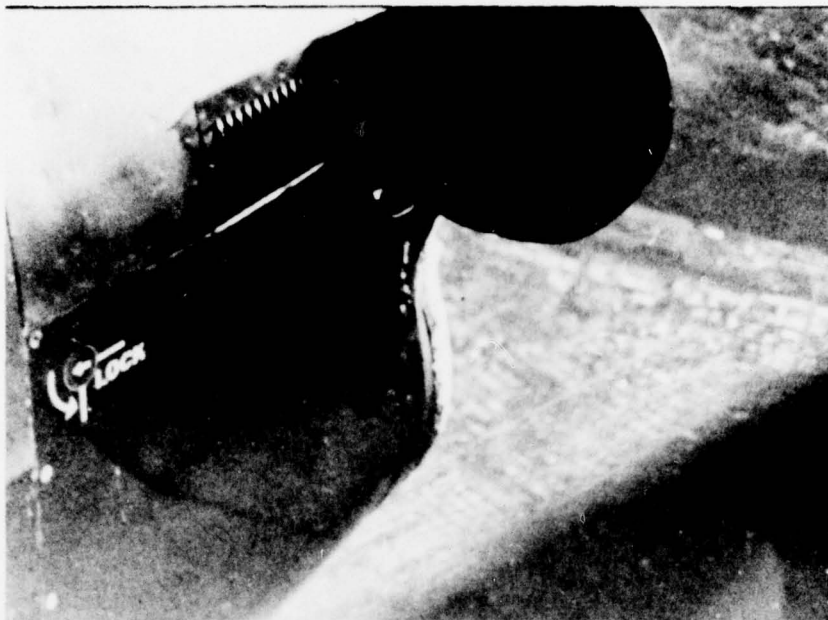
14. Photos 11 and 12, appendix B, show ice accumulation at the engine air inlet lip boots. Although this area incorporates electrothermal deicing and was in use at the time this photograph was taken, ice still formed on the lip boots. The air inlet boots were checked by maintenance personnel and found to be operational. Ice formation on the engine air inlet lip boots was typical for both aircraft. The inability of the engine air inlet anti-ice system to prevent formation of ice on the inlet lip boots is a shortcoming.

Photo 11. Rime Ice Accumulation on Engine Air Inlet Anti-ice Lip Boot.

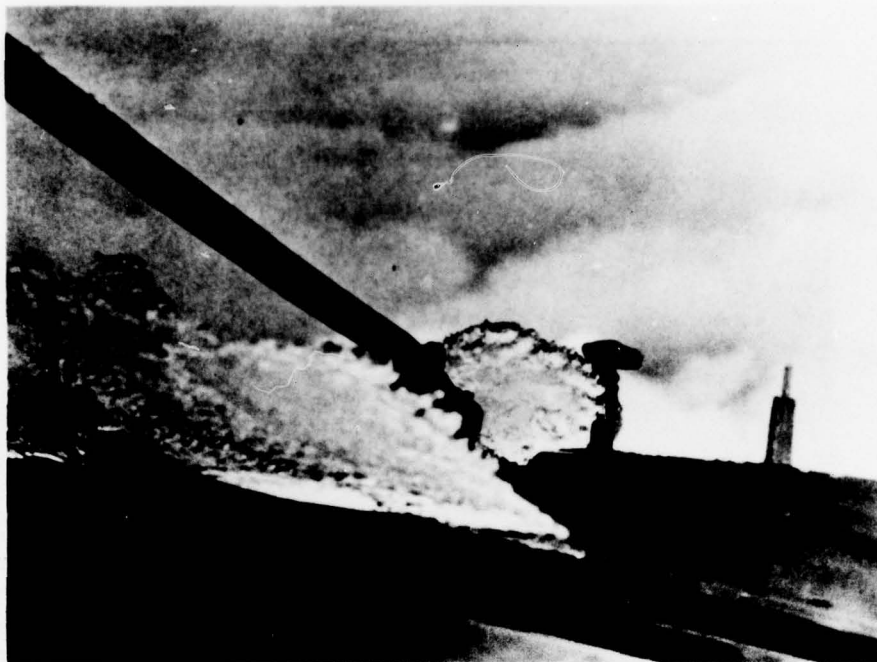
16. Ice accumulation and patterns of accumulation were the same for both aircraft except for ice formation on the windshields. The IR-painted aircraft incorporated a windshield electrothermal anti-ice system. The JU-21D with high gloss paint had an unheated windshield and could only use defrost air to prevent windshield icing. With use of the electrothermal system only a small amount of ice formed on the windshield (photos 13 and 14, app B), and most of this ice was in the area of the windshield wipers. Although considerably more ice formed on the unheated windshield, the defrost air did maintain an area of the windshield clear that was sufficient for landing the aircraft. One test was conducted after application of ice-phobic material to the windshield. The purpose of this test was to determine if ice-phobic material would prevent ice from forming on the windshield or enhance natural shedding. Although icing conditions were not encountered on this flight, further use of the ice-phobic material was discontinued when the pilot complained of reduced visibility and distortion.

Photo 13. Windshield and Windshield Wiper Icing on Test Aircraft.

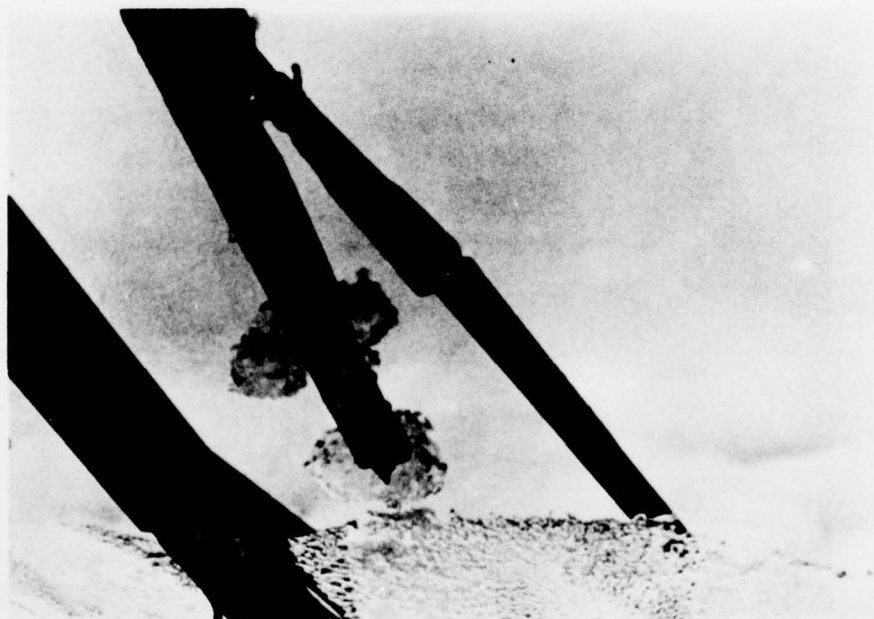
Photo 14. Windshield and Windshield Wiper Icing on Test Aircraft.

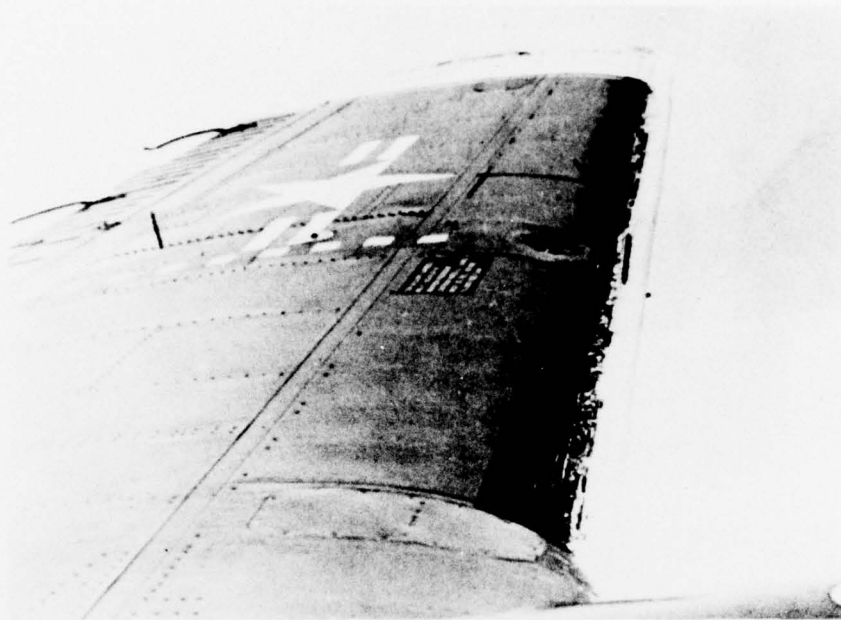
17. When ice accumulation reached an approximate depth of 2 inches, the aircraft could not maintain level flight at 140 KCAS with maximum power. Photo 15, appendix B, depicts the aircraft with an ice accumulation of 2 inches. After the pneumatic boots were activated power requirements were greatly reduced. However, because of the ice build-up on surfaces that do not have an anti-ice/deice capability, the power required after activation of the pneumatic boots was still increased over that for the initial entry conditions.

**Photo 15. Approximately Two Inches of Glime Ice Accumulation
on Leading Edge of Standard Aircraft.**

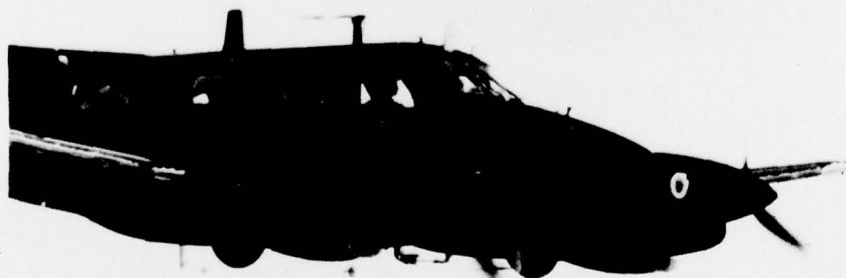
**Photo 16. Right-Side Front Quarter View of Test Aircraft
with Rime Ice Accumulation.**

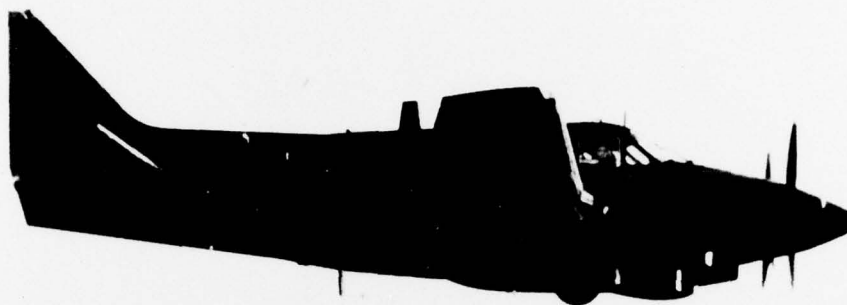
**Photo 17. Right-Side View of Test Aircraft
with Glime Ice Accumulation.**

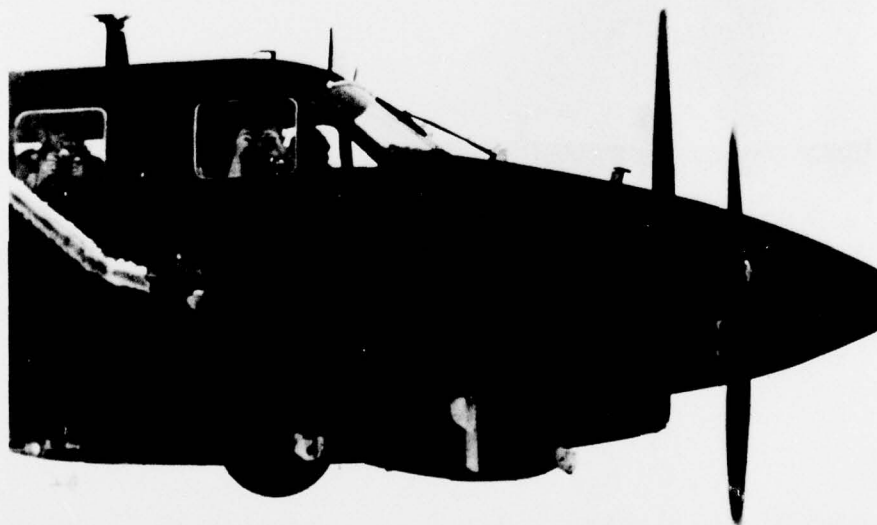
**Photo 18. Right-Side Nose-Section View of Test Aircraft
with Glime Ice Accumulation.**

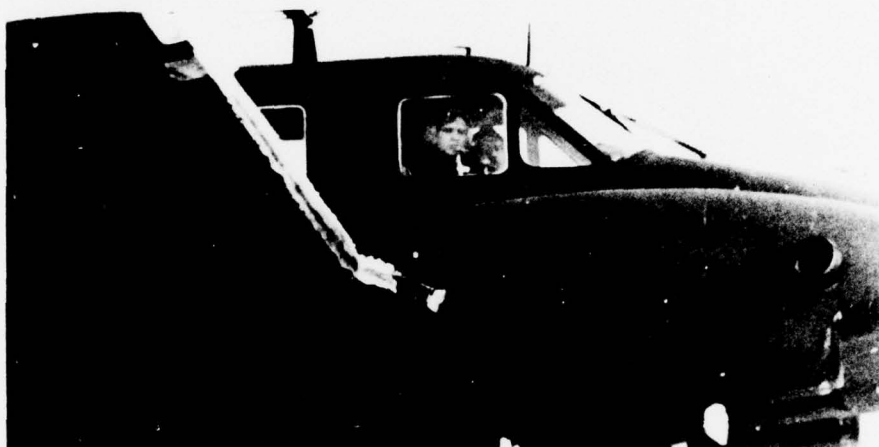
Photo 19. Right-Wing Leading Edge of Test Aircraft
with Glime Ice Accumulation.

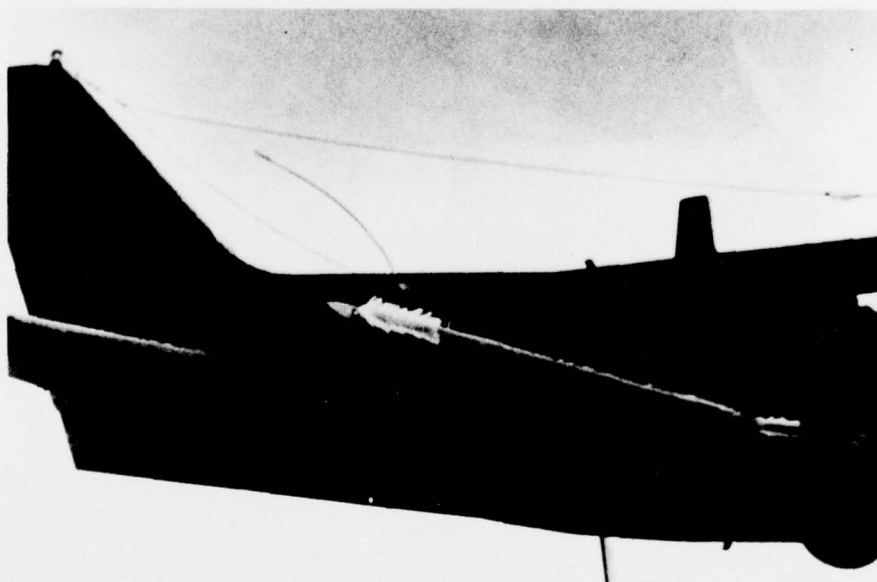
Photo 20. Right-Wing and Empennage of Test Aircraft
with Glime Ice Accumulation.

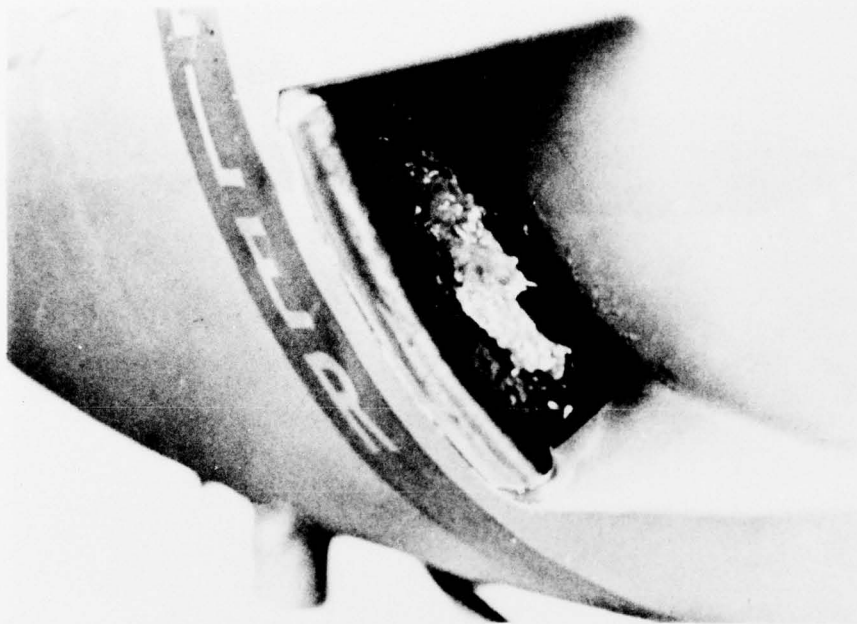
Photo 23. Environmental Control Ram Air Inlet
of Test Aircraft with Ice Accumulation.

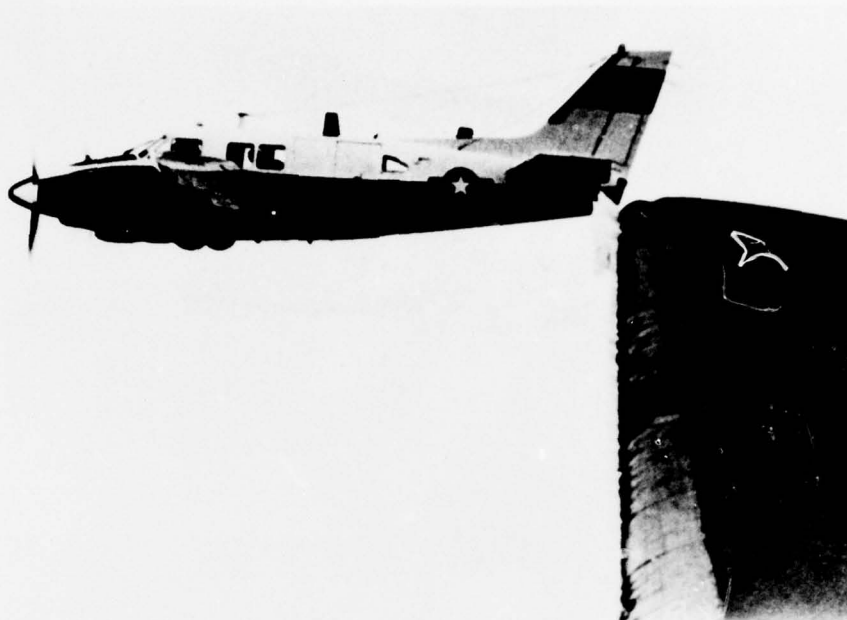
19. A substantial amount of ice (approximately 6 inches thick and 6 inches high) accumulated outboard of the pneumatic boots. This large build-up of ice is shown in photos 25 and 26, appendix B. Throughout the tests this large block of ice fell from the aircraft prior to landing. Should such a large piece of ice fall in a populated area, the result could be damage to property and/or bodily injury. The lack of anti-ice/deice capability for the wing area outboard of the pneumatic boots is a shortcoming.

Photo 25. Wingtip of Test Aircraft with Rime Ice Accumulation.

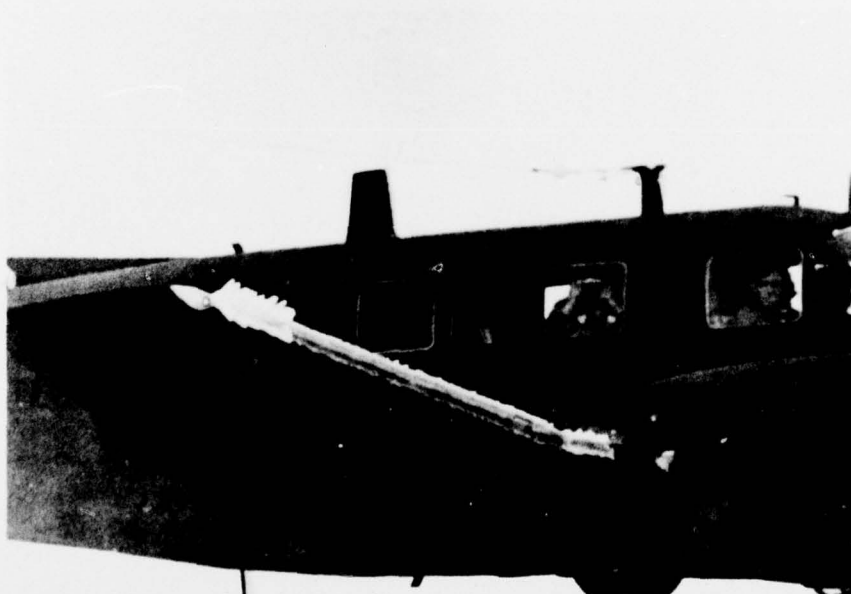
Photo 26. Wingtip of Test Aircraft with Rime Ice Accumulation.
